Problem Reading Temperature Sensor in Newly Installed MultiFlex RTU v. 310

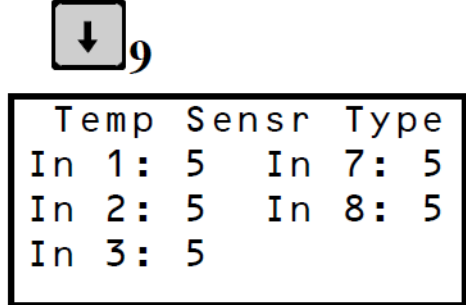
nine (9) times until the "Temp Sensr Type" screen is displayed. If this board is experiencing the problem described in this technical bulletin, the values will be invalid (some number other than 1, 2, or 3).

Press
